THE IMPACT OF THE OLD MINING WORKS IN BENTOMAK MINE - KRIVA PALANKA ON THE CONSTRUCTION OF THE ROAD INFRASTRUCTURE

Zoran Despodov, Dejan Mirakovski, Zoran Panov, Vancho Adjiski

Faculty of natural and technical sciences, Štip, R.N. MACEDONIA, zoran.despodov@ugd.edu.mk

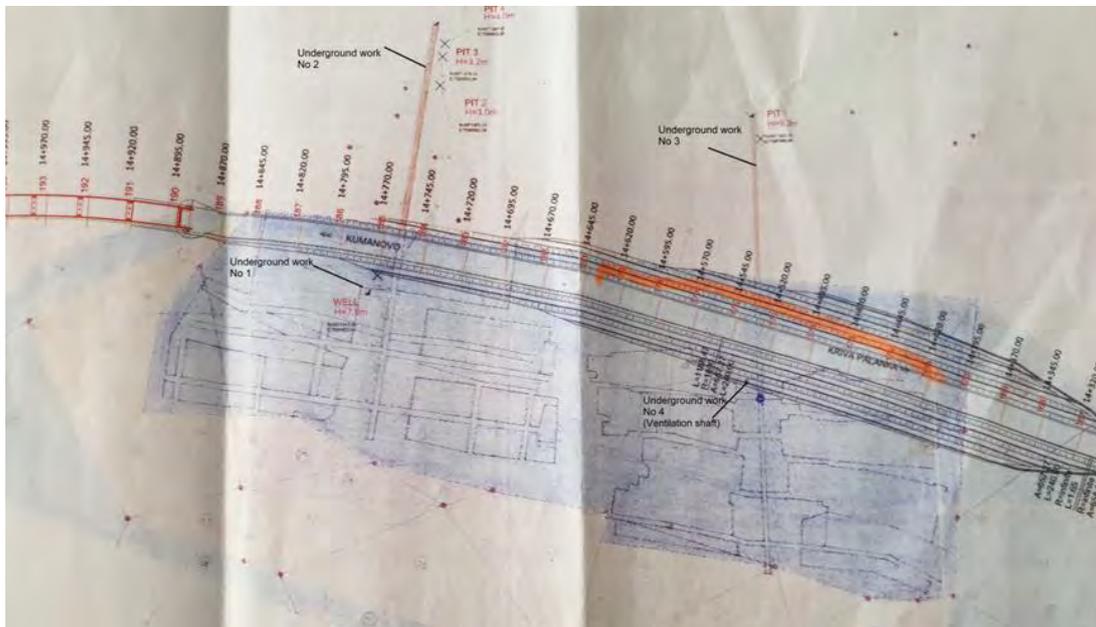
During the construction of the Mine, there were some changes in the concept of opening, so instead of one were built two hoisting declines, Figure 2. The main ventilation decline was not constructed because the hoisting decline served also as ventilation decline. The hoisting declines are connected with short ventilation shafts, Figure 2.

Figure 2. Plan of the actual condition of the underground mine for bentonite clay and location of the express road

- In the immediate vicinity of the express road alignment, four underground mining facilities have been identified, of which only facilities numbered 2 and 3, shown in Figure 2, intersect the route of the road;
- The position of their entrances is checked by surveyors, and they can also be seen on the surface as well;

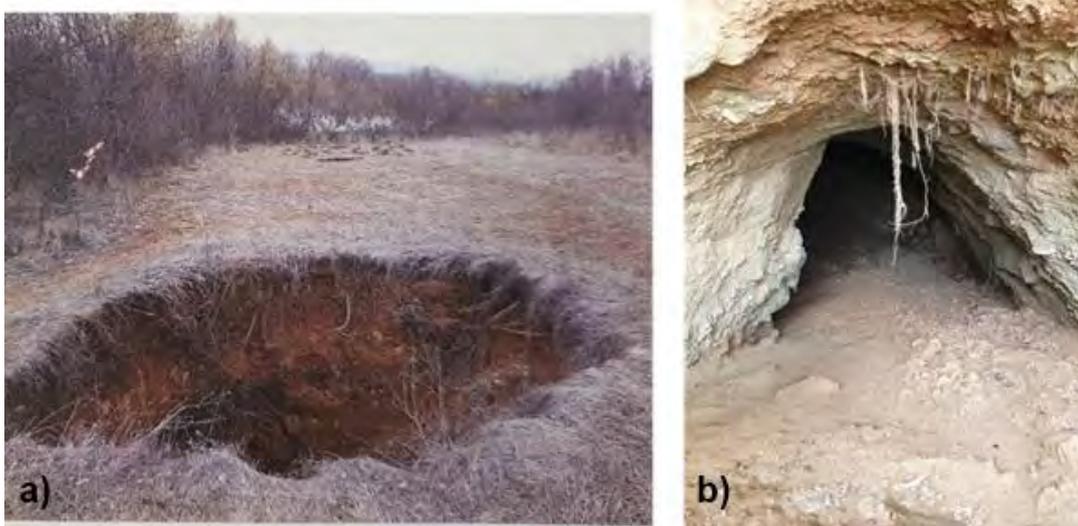
Figure 3. Photographs of old mining activities: a) Underground Ruins No.2 - Hoisting decline No.1; Underground facility entry No.3 - Hoisting decline No.2

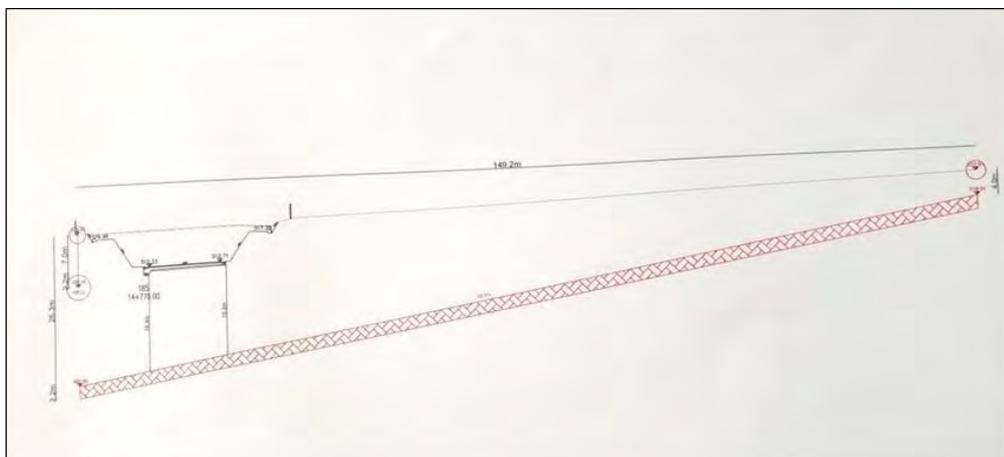
- At decline No.1, there is a visually noticeable ventilation shaft located on the left side of the road, at a station location, km 14 + 760;
- The entrance of decline No.1 is 110 m from the right edge of the excavation route, i.e. 150m from the left edge and it has dimensions: height 2.2m and width 3.0m;
- In the road zone, the hanging wall section of decline No.1 viewed from the side of its entrance- right side of the road is located at a depth of about 15 m from the projected elevation of the asphalt road, and the left side of the asphalt road is at a depth of approximately 17 m, and it passes under the route at, km 14 + 760, Figure 4;

Figure 4. Estimated Location of hoisting decline No. 1 in relation to final road condition

During the construction of the road, the contractor must perform the excavation work with particular caution, especially in the places where the old mining activities cut the route of the road at depth. At these sites, georadar measurements and investigative drilling are required in order to accurately determine the position of the declines under the road. Once the exact location of the underground facilities has been determined it is desirable to fill in the empty spaces by injecting a concrete mixture. This will permanently stabilize the road, bearing in mind that it will be specifically loaded at the time of its use and subject to both static and dynamic loads. The part of the excavations stopes especially in the immediate vicinity of hoisting decline No. 2, will have no impact on the road. Possible slopes in the hollow spaces formed by the stopes are in favor of slope stabilization and there will be no possibility of landslides on the road.

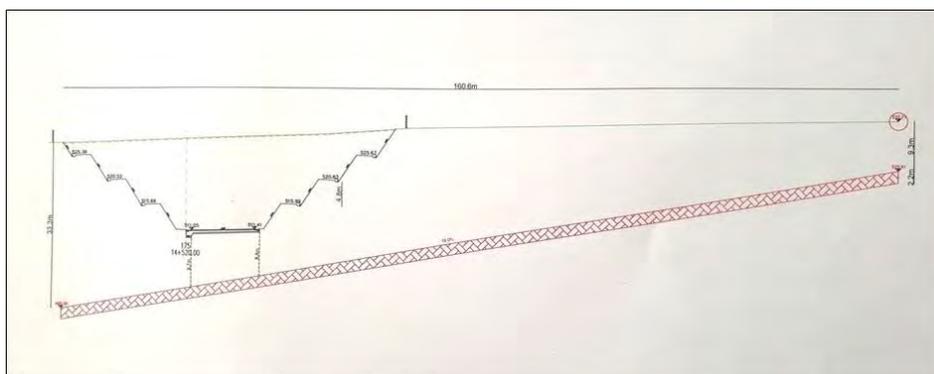
- The entrance of the decline No.2 is 100m from the right edge of the excavation of the road, i.e. 160m from the left edge, and has dimensions of 2.2m height and 3.0m width, Figure 5;

- In the road zone, the hanging wall section of decline No.3 viewed from the side of its entrance - the right side of the road is located at a depth of about 8.5 m from the projected elevation of the asphalt road, and on the left side of the asphalt road is at a depth of 10.5 m, and it passes under the route of km 14 + 530, Figure 5.

Figure 5. Estimated Location of hoisting decline No. 2 in relation to final road condition
