PROCEEDINGS OF THE VII INTERNATIONAL GEOMECHANICS CONFERENCE

REHABILITATION OF THE LANDSLIDE – MONITORING, MEASURES AND PROCEDURES
FOR FAST REHABILITATION

Zoran Panov¹, Radmila Karanakovska Stefanovska¹, Kirco Minov², Blagica Doneva¹, Risto Popovski¹
¹University Goce Delcev, Faculty of natural and technical science, Stip, Republic of Macedonia,
zoran.panov@ugd.edu.mk
²Copper mine Bucim, Radovis, Republic of Macedonia

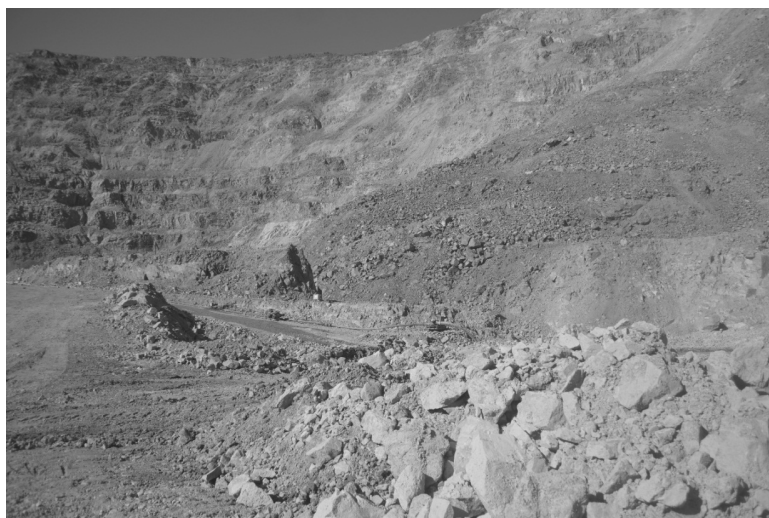
Analyzed was slope stability in the north, northwest and northeast, respectively, in the area where registered geotechnical instability. An analysis was made in the area covered by the profiles: P-0 - P-0', P1 – P1' и P2 – P2'. The appearing landslide, emerging deformations of the terrain above all material cracking in open pit indicate that geotechnical space is unstable.

Fig.1 Appeared landslide (view from the north-east)

- The opening of the lower benches in order to achieve the required capacity of exploitation of ore conditions and further disruption of already disturbed geotechnical material.
- This year is especially moist with large precipitation. Appearances of atmospheric water in open pit, her untimely prevention, and increase the level of underground water and they increase as the causes of geotechnical instability. Accumulated water at the bottom of the open pit, suggesting that the bottom of the open pit, and thus the benches above it, is on the water with a possible increase

- Ensure to be exploited under a **valid mining project**, in accordance with the dynamics of development, in plan and in depth.
- For any change must be made **new additional mining project** that will cover not only the stability of the slope of the excavated blocks, but also changed the geometry, quantity of ore and tailings transport routes and what changed.
