## PRELIMINARY INVESTIGATIONS OF DETERIORATION ON MONUMENT TO FALLEN SOLDIERS IN THE SECOND WORLD WAR IN ŠTIP, REPUBLIC OF MACEDONIA

**A b s t r a c t:** This paper gives an explanation of the origin and formation on the minerals which are formed as a consequence on deterioration. Several small marble samples were collected for research by Scanning electron microscopy (SEM), coupled with an energy dispersive X-ray spectrometer (EDS). SEM is especially useful because it gives elemental, mineralogical and morphological data at the same time. Loss of face characters and presence of black crusts are evident. The results show that the black crusts consisting of gypsum, calcite and elements such as Si, Al, Fe, Pb, Ti, Zn and Mn, were being formed from interaction between the marble surface and atmospheric pollutants. Dissolution of calcite from the surface by rain water, CO<sub>2</sub> and SO<sub>2</sub> enables the Fe compounds to become enriched and oxidized on the surface. Clay minerals are occur in the finishing layers covering the surface on the monument and they originated from atmospheric dust naturally deposited.

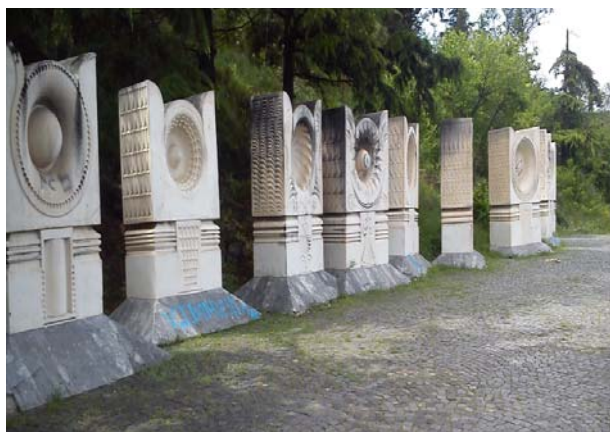
The research was carried out on the memorial monument to fallen soldiers in the Second World War. The monument is located on the eastern side of the fortress Isar in Štip. Location and view of the memorial monument are showed in Fig. 1.

Fig. 1. Location and view of the memorial monument to fallen soldiers in the Second World War, Štip

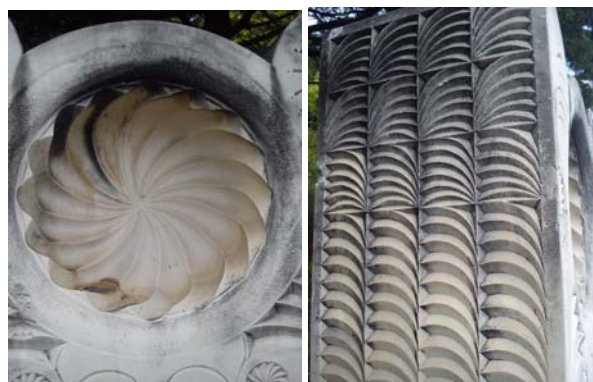
Fig. 2. Dendritic black and thin black encrustation

Loss of face characters and presence of black crusts are evident. The encrustation examined is formed on exposed marble as products of the interaction between the stone surface and atmospheric pollutants (dendritic black and thin black encrustation, Fig 2). Black crust is mixture of crystals of calcium carbonate and calcium sulfate. Such salts, which are formed on marble surface due to acid rains, are first washed away and later, because of water evaporation, are precipitated again, often incorporating black carbon particles.
