Initial bone loss around dental implants – CASE REPORT

Author : Krmzova Valentina, Co – Author : Petrushevski Andrej

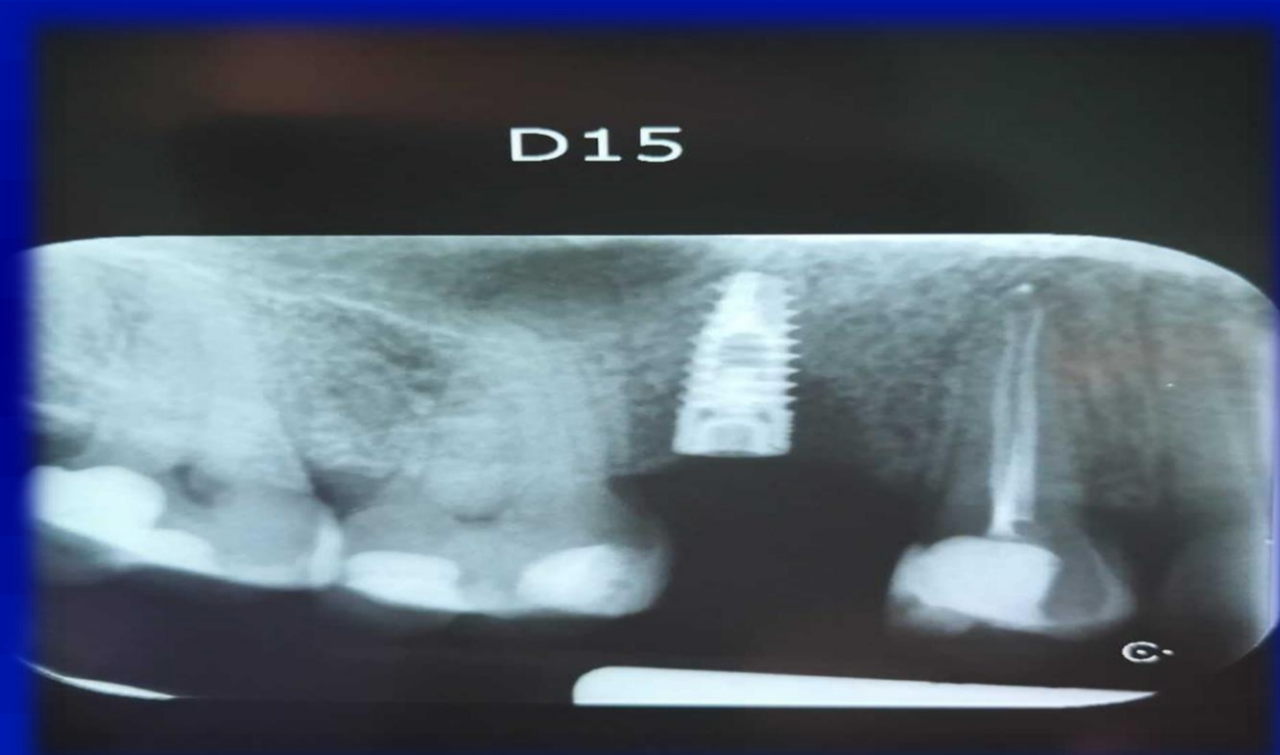
1.1. X - ray control before intervention of explanation

After the x - rays, we have noticed that we must extract the implants, making bone augmentation with an osteoconductive bone graft and making another implants-prosthetic solution.

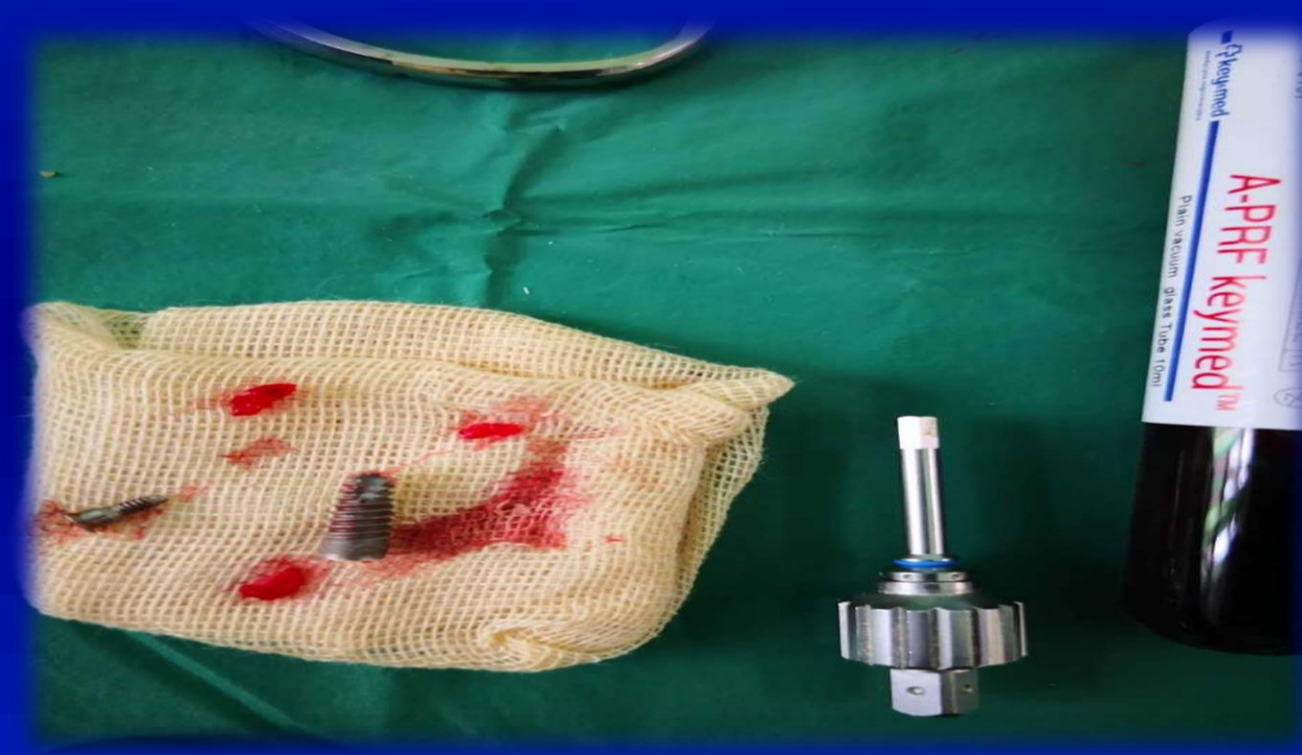
1.2. explantation (6 month after placement) of dental implant with periimplantitis

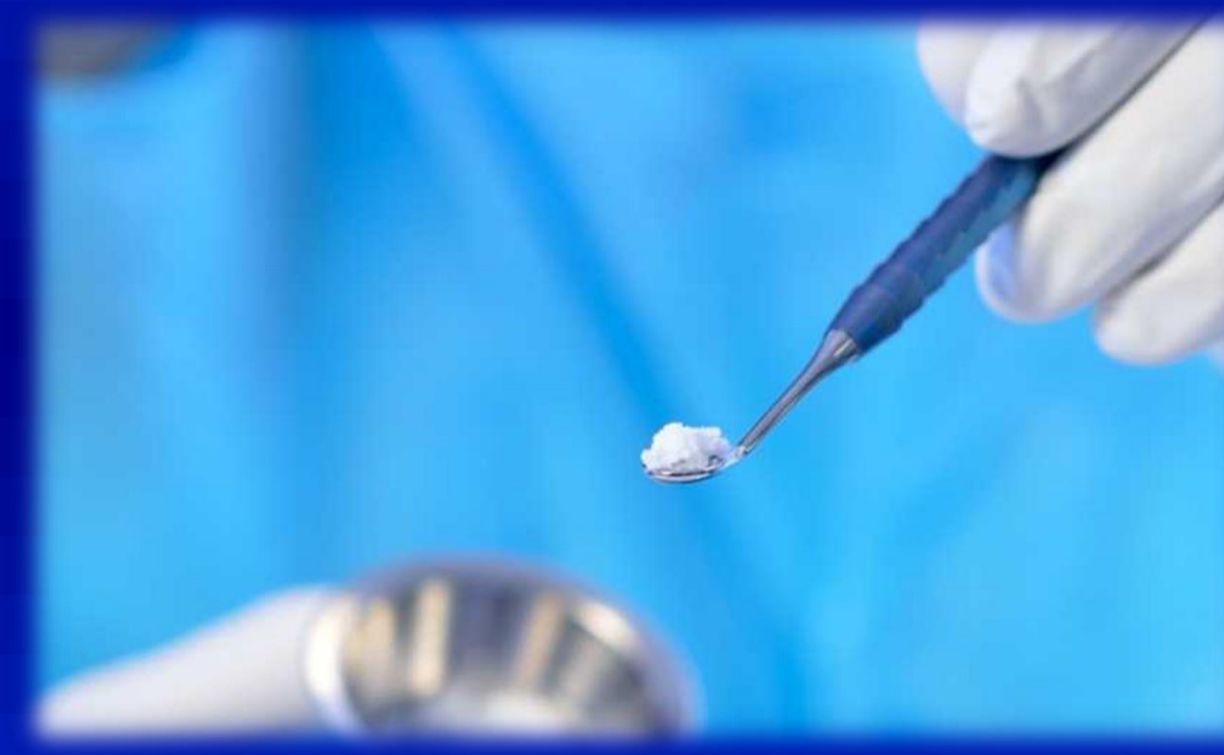
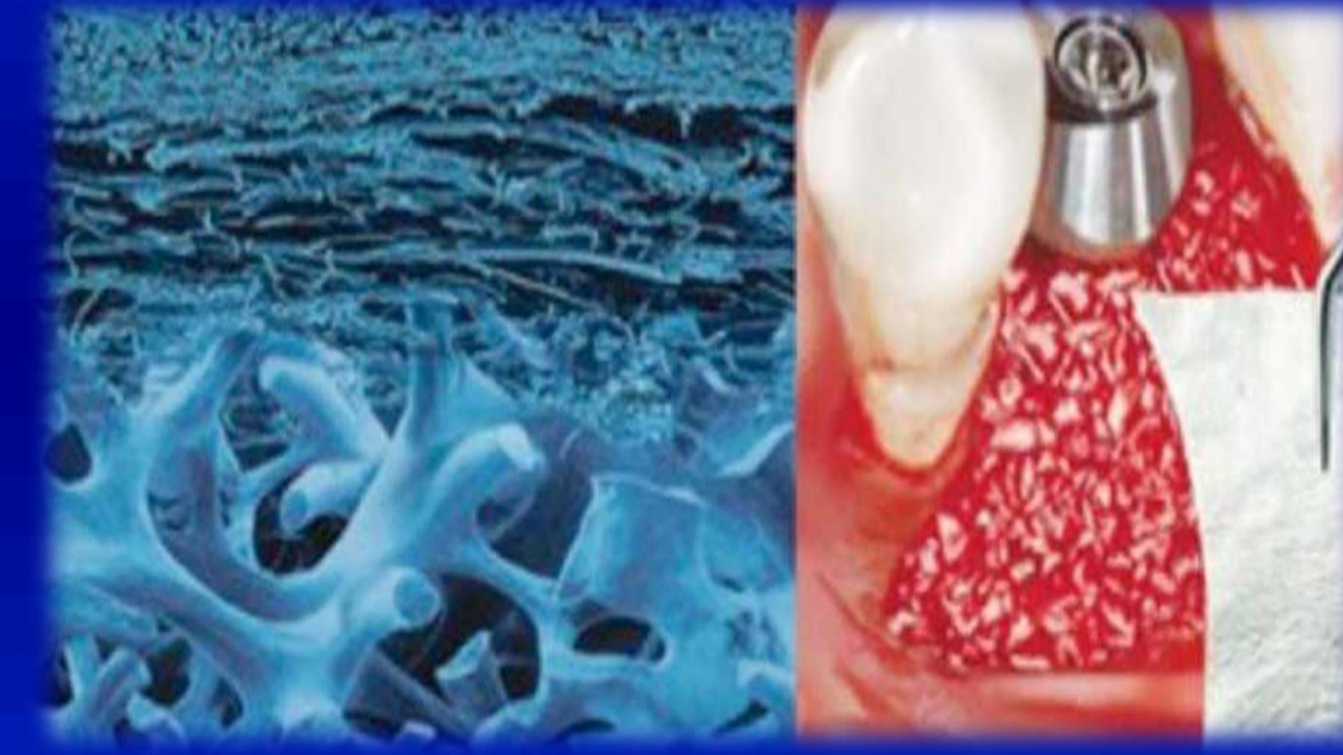
1.3.; 1.4. osteoconductive bone supstituent and collagen membrane

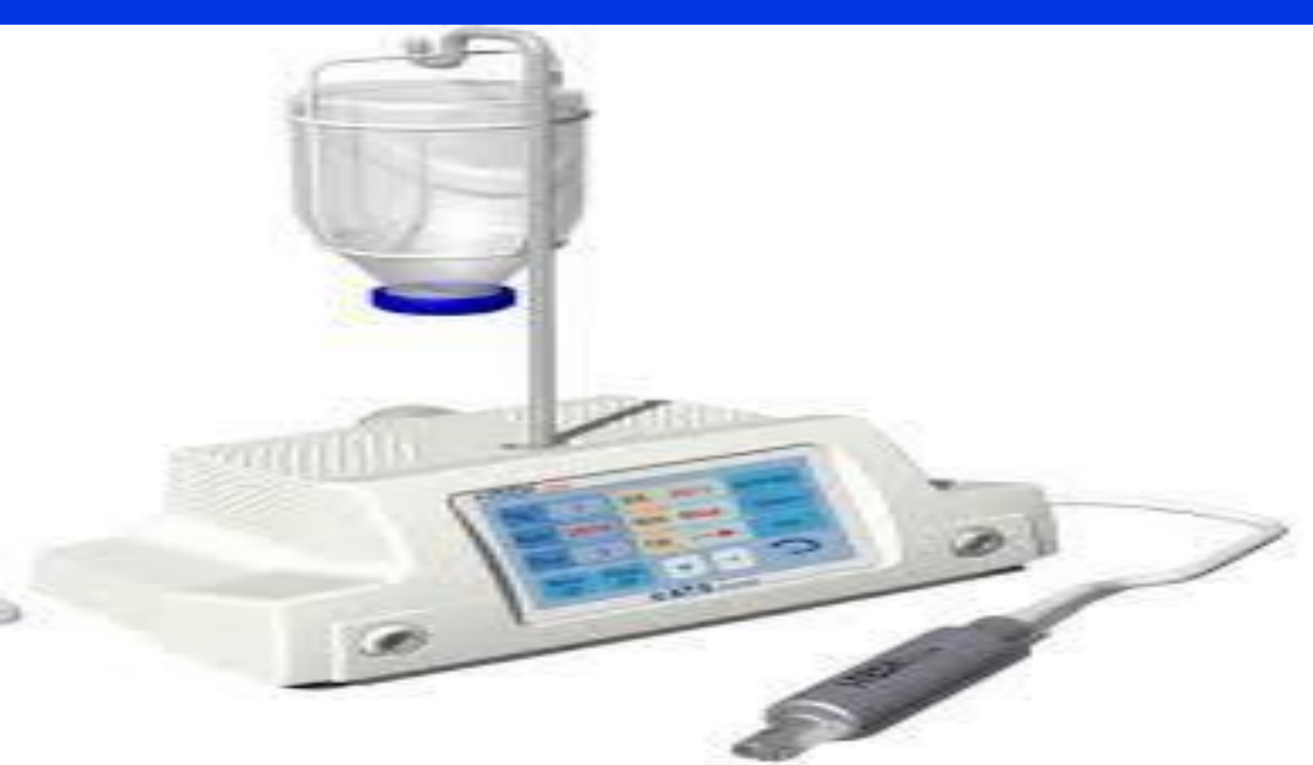
1.5. Fissiodispenser and drill instruments who help us to made implantation site but and bone trauma?

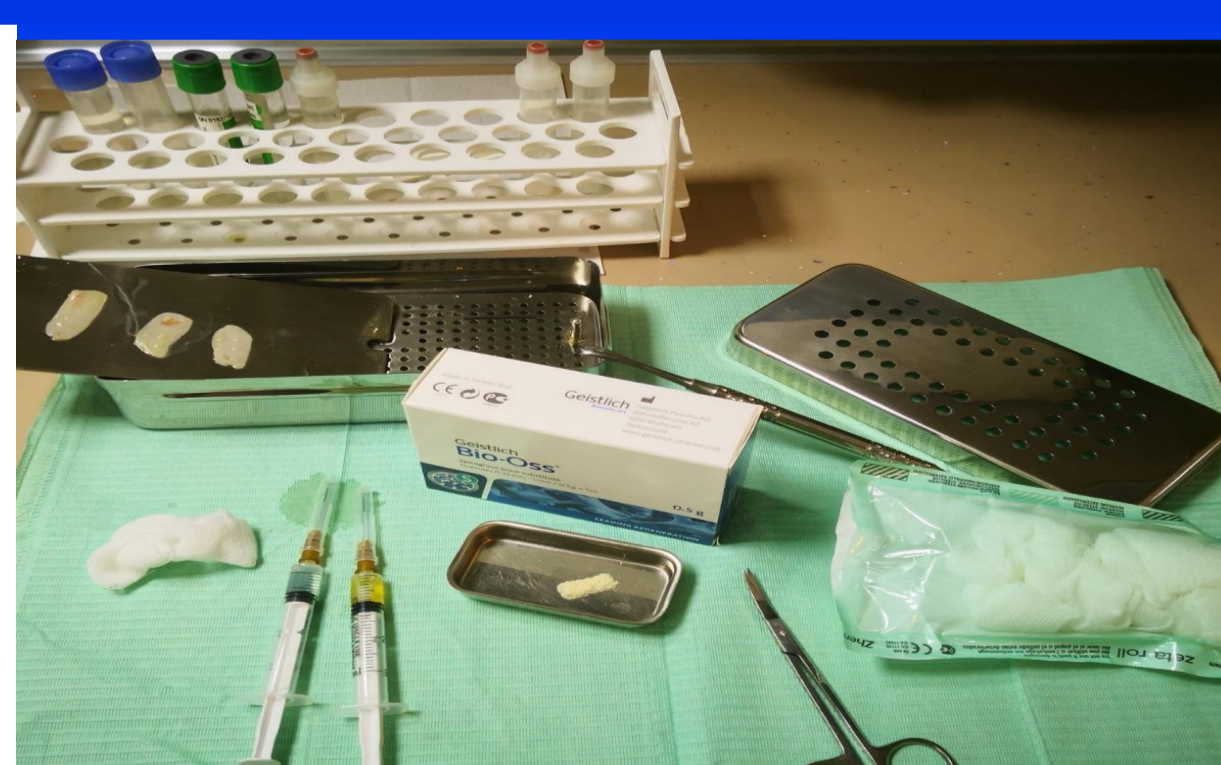
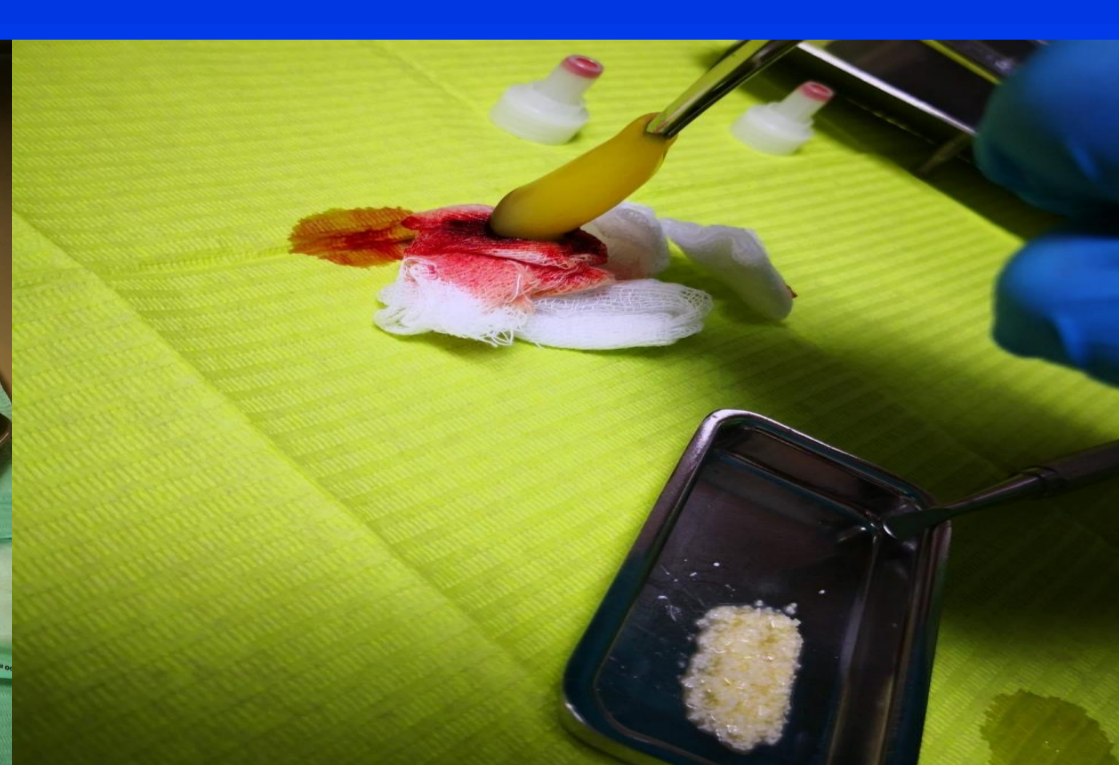
1.6.; 1.7. PRF membrane and sticky bone

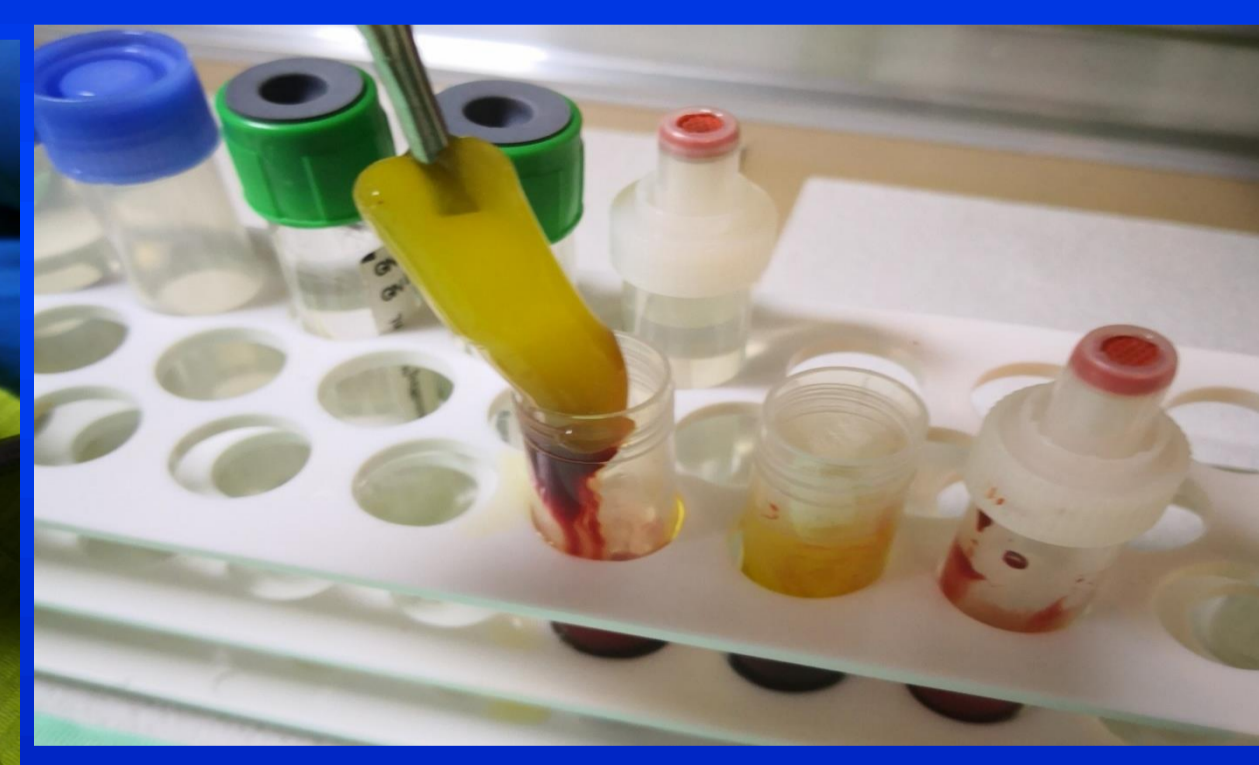
1.8. PRF membrane

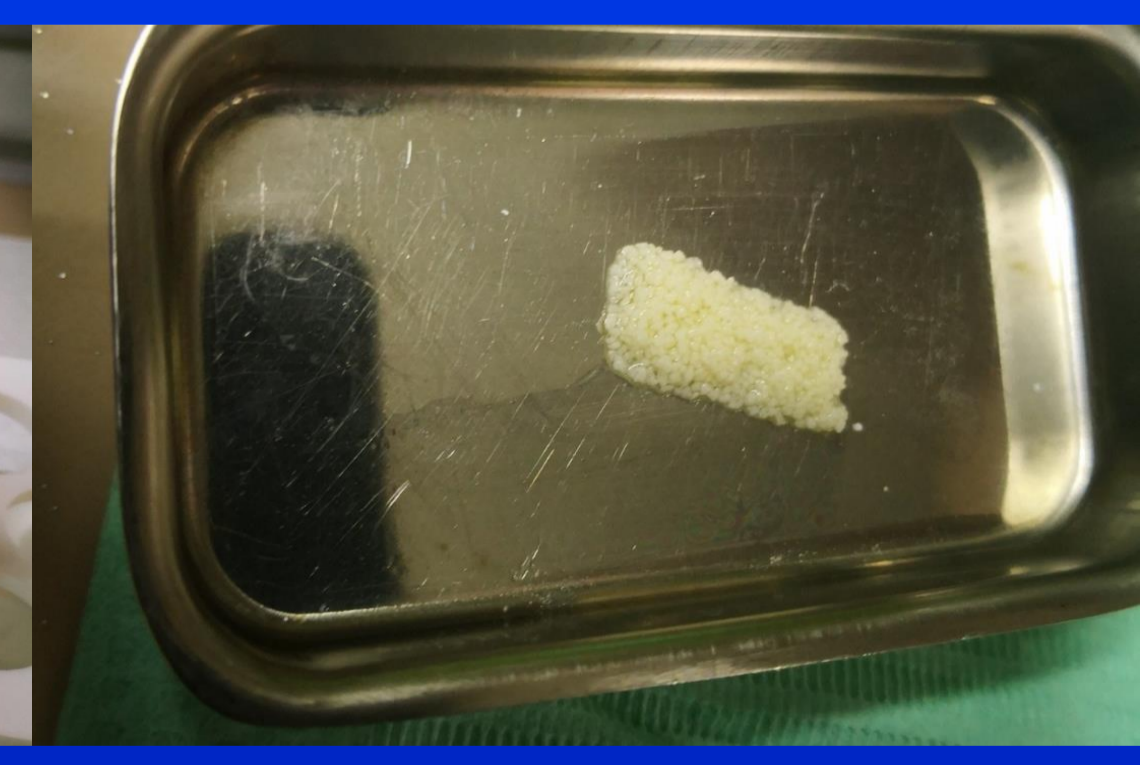
1.9. Sticky bone
