APPLICATION OF 3D POINT CLOUD DATA FOR CUT SLOPE MONITORING

Igor Ivanovski¹, Nataša Nedelkovska², Igor Peševski³, Goše Petrov⁴,
Milorad Jovanovski³, Toni Nikolovski¹

Abstract: This paper discusses the monitoring of slope instability during the construction of an expressway. As a basis, appropriate geological and engineering-geological investigations were carried out, supported by the application of practical sensing and analysis techniques, including drone-based imaging. The main goal is to present an example of the detection and monitoring of slope movements using a 3D point cloud obtained from the low-cost, remote, and precise SfM (Structure from Motion) technique, and appropriate software. The analyzed area represents a small part of a slope cut on the A2 Expressway Kriva Palanka-Stracin, in the Republic of Macedonia, which is under construction. The slope cut is excavated in albite-epidote-chlorite schists. In geological terms, it was found that this part of the cut has favorable conditions for the occurrence of instability. Four different point cloud sets were analyzed from four different surveys conducted over a total of five months, both before and after the occurrence of

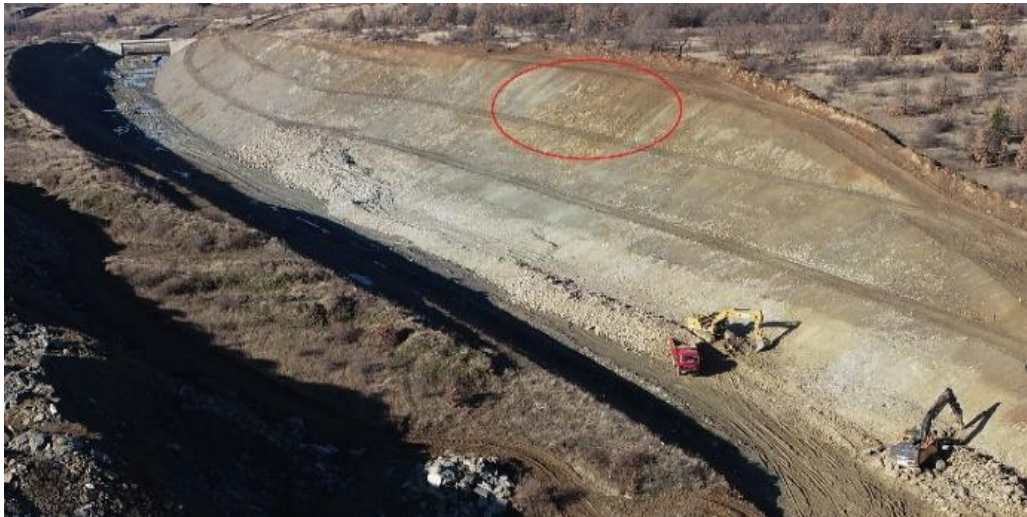
Fig. 2. Aerial look at the cut before the occurrence of the new landslide, where the studied area is marked with a red circle

slopes, they stayed stable for another year (Figure 2).

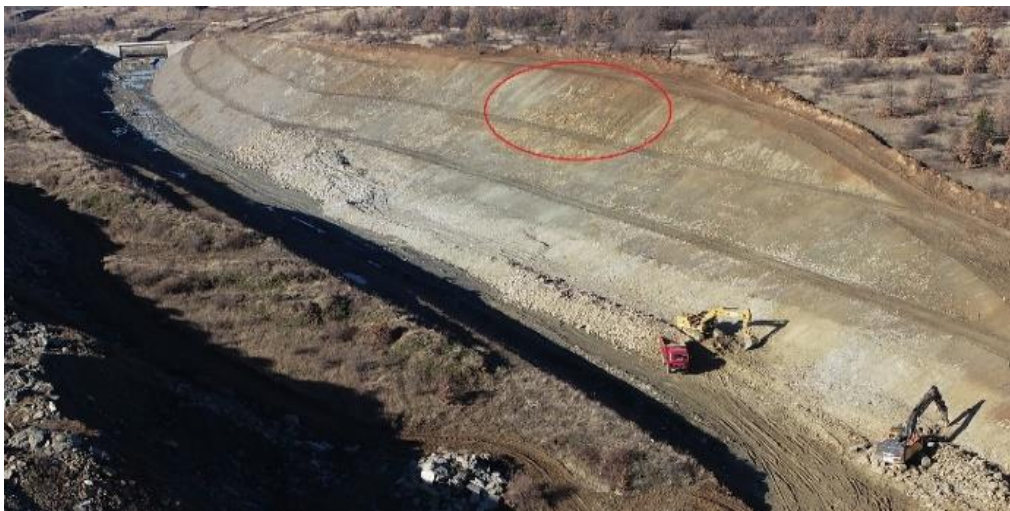
Fig. 3. Landslide condition on 27.09.2023

In the subsequent period, the dimensions of this landslide increased, as a result of which additional amounts of rock material were falling off the slope (Figure 3).

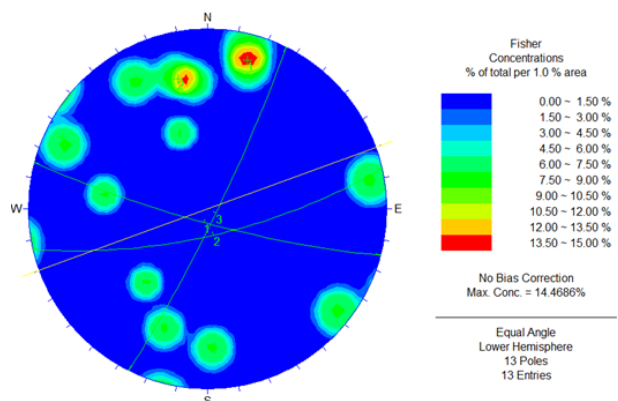
Fig. 6. Contour diagram of dip direction and dip angle of the joints

From the contour diagram (Figure 6) of the alignments of the maximums it can be seen that there are more joint systems with different orientations (strike), but most of them have steep to sub-vertical dip angles. Most joint systems have strike E-W, ENE-WSW, and ESE-WNW, with angles close to sub-vertical. Such strike and dip of the joint systems in relation to the main plane of the foliation, which is unfavorable to the pavement construction, further worsens the existing situation. It is about the appearance of a system of joints that cause fragmentation, that is, the separation of blocks and smaller parts of the schist to break off. In this case, we have ideal conditions for the occurrence of instability.

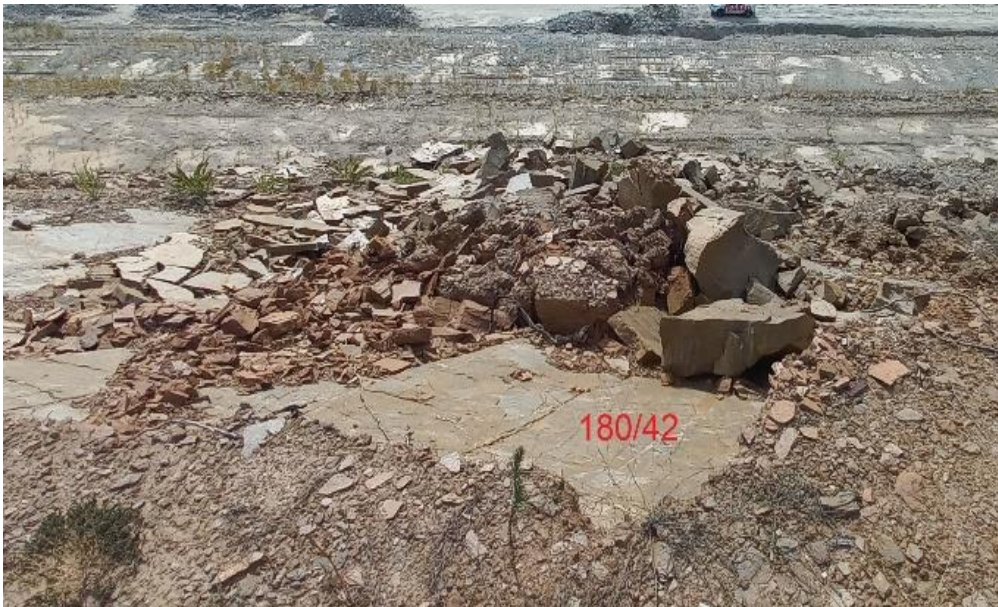
Fig. 7. The new sliding of the rocky material occurred on the upper part of the third slope with a dip direction and dip of the foliation of 180/42°

tion activities for the alignment of the road and construction of the cut. Near this area tectonic zones (faults) are present as well as planar fractures and joint systems, so at many places unstable zones are found, and fallen rock masses with a tendency to fall and slide towards the lower parts of the slopes (Figure 7).

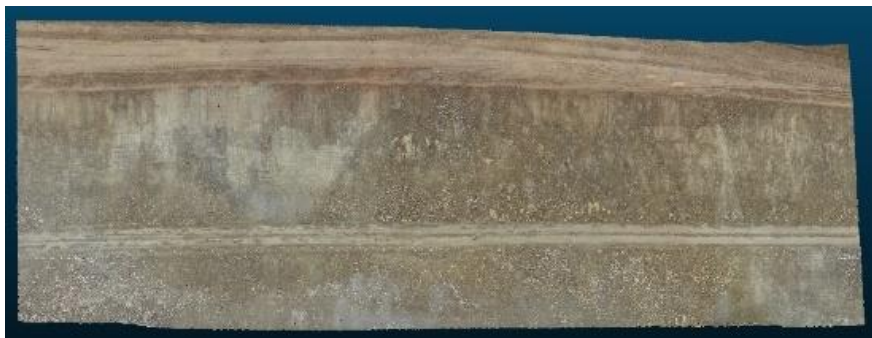
Fig. 10. First survey on 13.12.2022

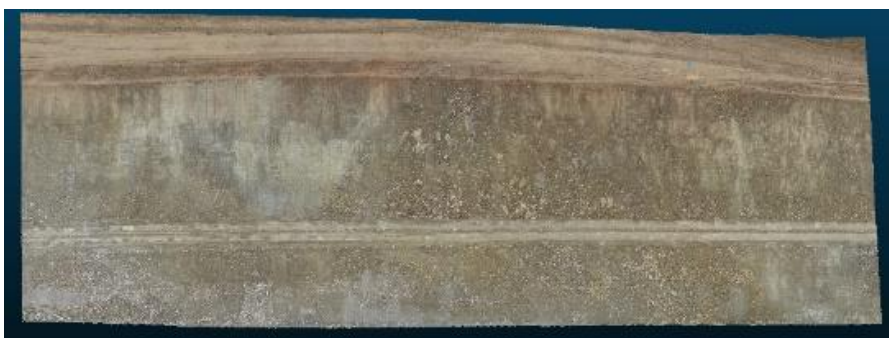
Fig. 11. Second survey on 20.01.2023

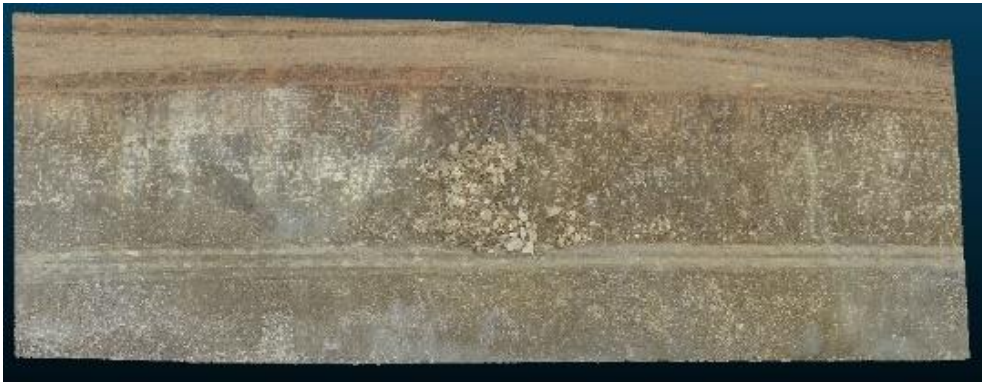
Fig. 12. Third survey on 21.02.2023

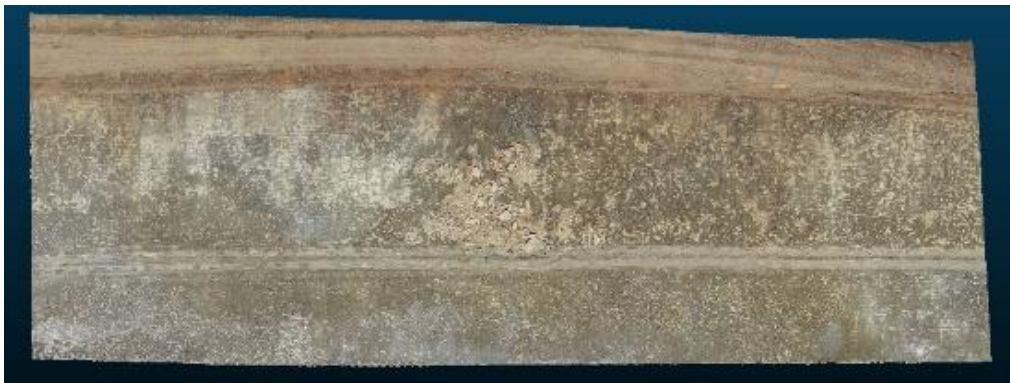
Fig. 13. Fourth survey on 16.05.2023

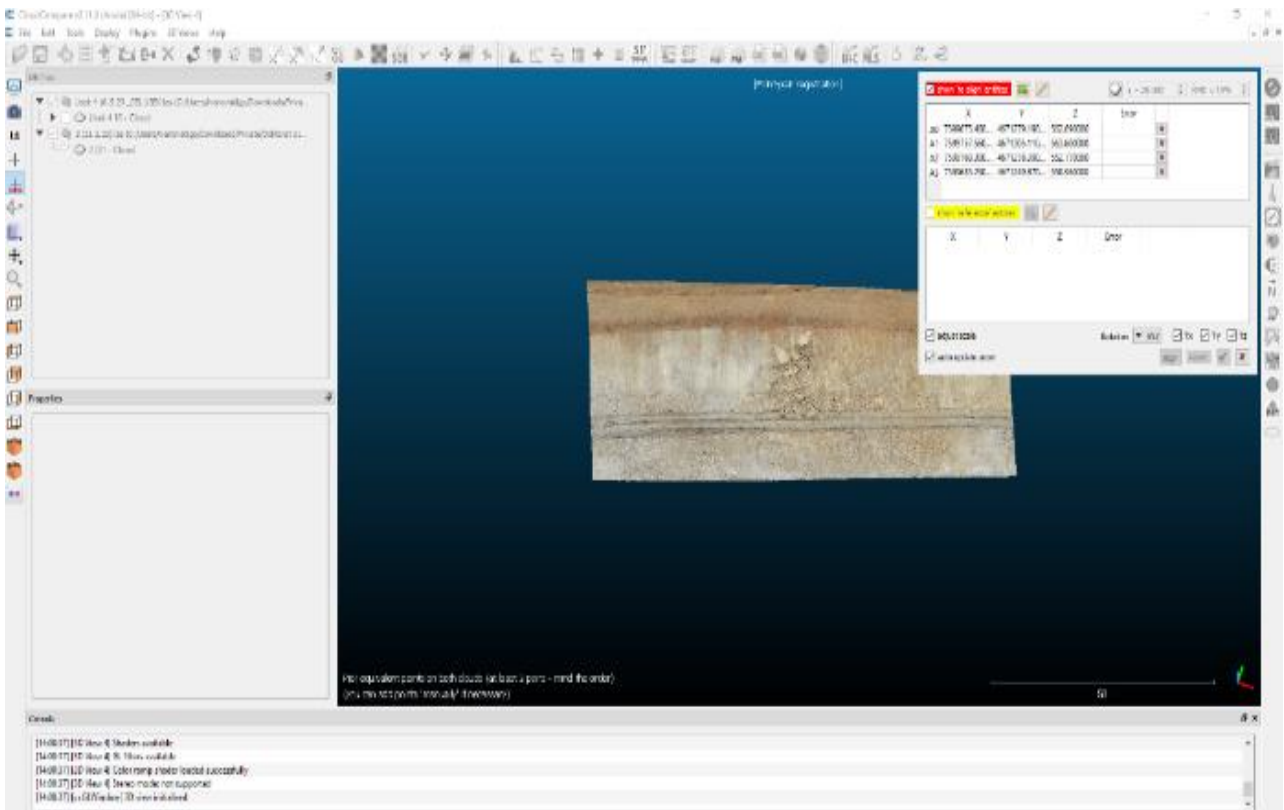
Fig. 14. Georeferencing the point cloud in CloudCompare software

The next step was georeferencing the point cloud and positioning it in a known coordinate system. Four control points from each point cloud had to be selected to align the point clouds together (Figure 14). The coordinates for these points were obtained previously using a GPS survey.

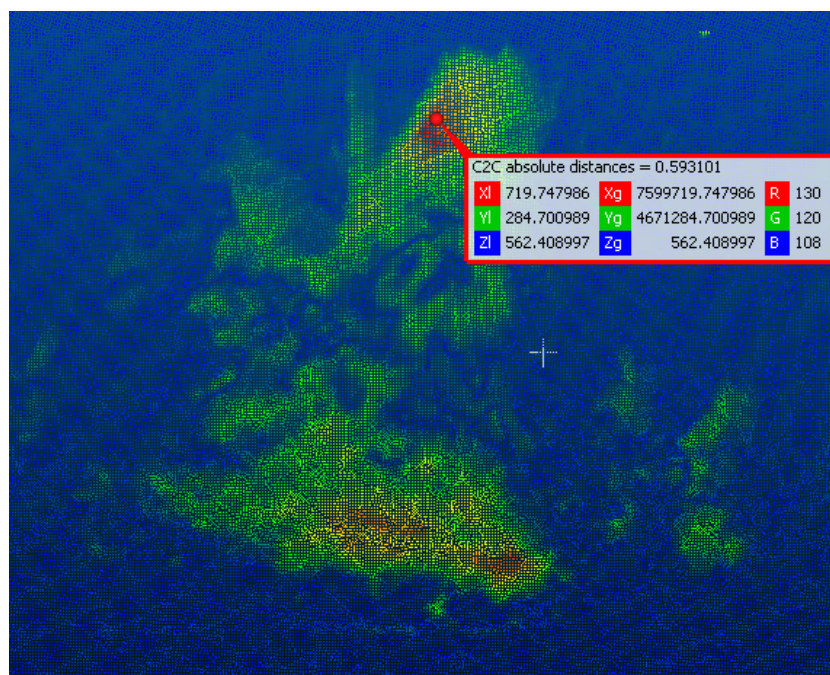
Fig. 17. Comparison between the first and the third survey with the maximum absolute distance

that was taken after the occurrence of the landslide, that is, the third survey, it can be said that the greater difference between the two clouds of points in the part of the researched area is already noticeable (Figure 17). Apart from the fact that this type of landslide is already observed on the spot, using CloudCompare, displacements can be measured in different places of the landslide, with the largest absolute displacement being 59 centimeters.
