Icon Resin Infiltration for managing dental lesions - Case report

Longurova Natasha, Zlatanovska Katerina, Atanasova Sandra, Kovachevska Ivona, Zarkova Atanasova Julija, Nikolovski Bruno, Stevkovska Cvetkovska Elizabeta, Nashkova Sanja, Mladenovski Marko. Arsovski Ljupka
Faculty of Medical Sciences, Goce Delcev University, Stip, North Macedonia

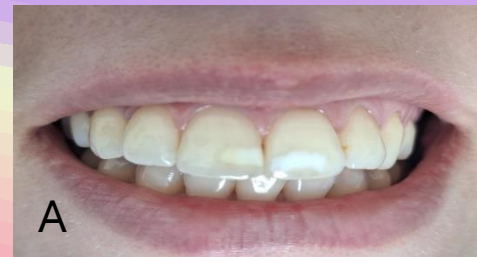
Case Description: A female patient aged 32 years reported a complaint of whitish patches on the front teeth. The patient was explained about various treatment options, and decided to be treated with Icon resin.

(A) Patient before treatment (B) Teeth polishing (C, D) Icon etching (E) Icon drying (F) Icon infiltration (G) Light curing (H) Patient after treatment

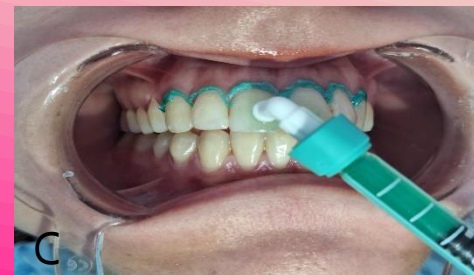
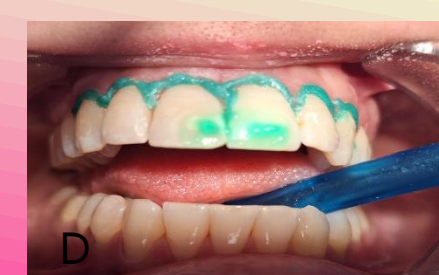
The procedure was performed with currently available Icon Resin which contains three components: Icon-Etch: 15% hydrochloric acid, Icon-Dry: 99% ethanol, Icon-Infiltrant: methacrylate-based resin matrix.

Conclusion: It is a microinvasive procedure where etching only erodes 30 to 40 μm of enamel, which is then infiltrated with resin. Also can remove caries in lesions that are too advanced to be treated with fluoride.
