Marginal bone resorption at dental implant – RTG analysis

Research Article

Abstract

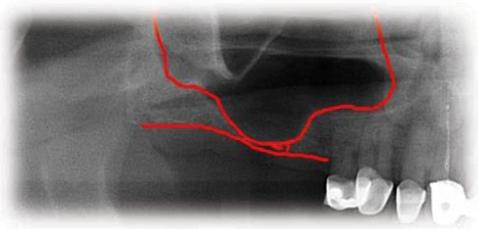
Figure 1: Lowered maxillar sinus.

X-ray methods are used are the orthopantomograma of the jaws, lateral cephalometry, periapical radiography, occlusal X-ray, conventional and computed tomography [7]. In computed tomography a three-dimensional image is obtained - shows the configuration of the bone not only in the sagittal but also in the transverse it provides innovative radiological technology, which undoubtedly replaces the conventional film-based technology in all forms used in dentistry [8]. We made a digital volume tomography in a patient in the area of the maxillary lateral quadrant, which indicates that we have a lowered sinus. Using this RTG analysis, we make the treatment plan (Figure 1).

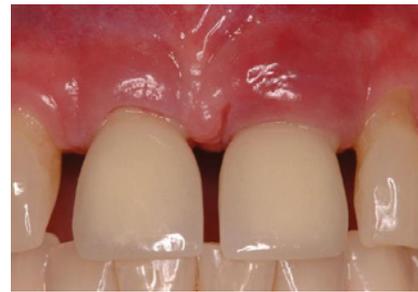
Figure 2: Peri-implant mucositis.

- Peri-implantitis characterized by progressive, inflammatory destruction of the alveolar bone around the implant. Deepening of the gingival sulcus occurs, the purulent and bloody contents are drained during the projection [10,11] (Figures 2,3).

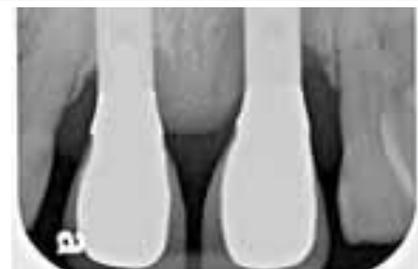
Figure 3: Peri-implantitis.

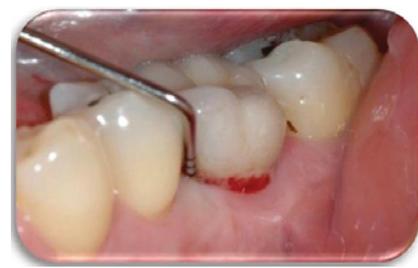
Figure 4: Peri-implant mucositis, bleeding on probing.

In peri-implant mucositis, the marginal gingiva in lightly bleeding bleeds. Gingiva is hyperemic and oedematous. The patient feels discomfort, mastication of food also leads to bleeding (Figure 4) [16].

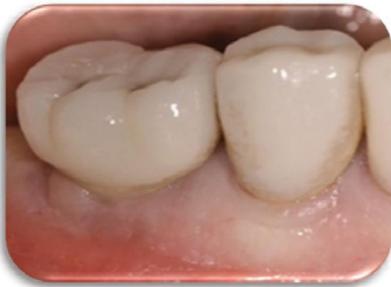
Figure 5: Peri – implant mucositis.

With the progression of the peri-implant mucositis, the soft tissue condition around the dental implant is aggravated. Bone tissue destruction begins inside the alveolar bone around the implant itself, causing bone resorption. This process is irreversible in relation to peri-implant mucositis that is a reversible process (Figures 5-7) [17].

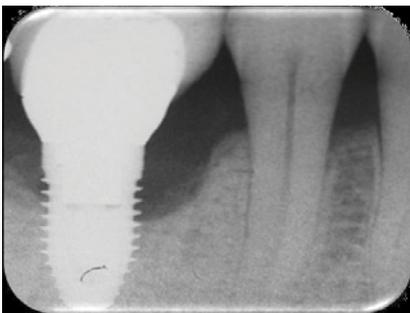
Figure 6: Xray reveals of peri-implantitis with bone resorption.

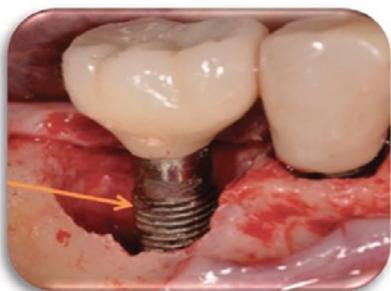
Figure 7: Surgery exposure of the place where there is bone loss around the dental implant.

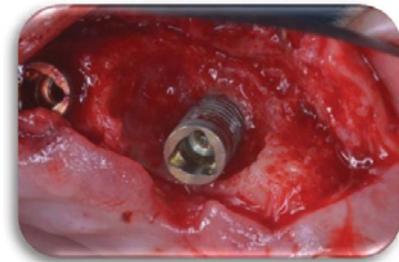
Figure 8: Early stadium of peri-implantitis.

An early stage of peri-implantitis is when the clinical examination in the patient, in the course of the probing, the depth of the gingival sulcus is. In the case of probing, there is a cranny and sometimes drainage of purulent contents. Marginal bone resorption is <25% of the length of the dental implant.

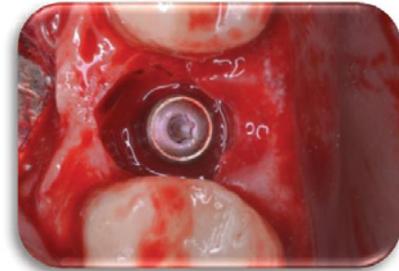
Figure 9: Moderate stadium of peri-implantitis.

A moderate stage of peri-implantitis exists when, when probe around the dental implant, the probe in the gingival sulcus collapses and drainage of bloody or purulent content occurs. Bone tissue resorption is from 25% to 50% of the length of the dental implant.

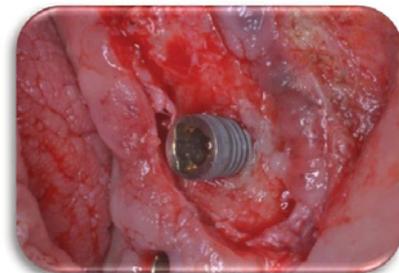
Figure 10: Advanced stadium of peri-implantitis.

Late stage of peri-implantitis, we have when when probe around the dental implant, the probe falls into the sulcus in depth. Bleeding and purulent content drainage is being drained. Bone resorption is > 50% of the length of the dental implant (Figures 8-10) [18].

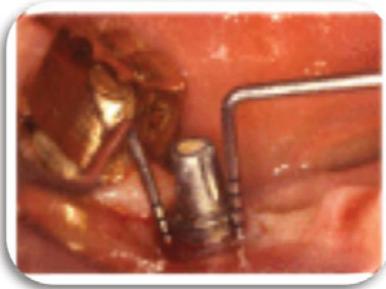
Figure 11: On the probing, the mesial depth is 11 mm and the distal depth is 12 mm.

The first patient was at the age of 48 with male gender and generally with good health. There are no contraindications to make oral surgery. The patient is not allergic to any medication. A dental implant was placed 12 months ago (Figures 11,12), the dental implant's position was 46. The implant was 4.1 mm in diameter and 12 mm in length. The patient has peri-implantitis, a RTG intraoral radiography image was recorded and marginal bone resorption was observed. The depth of the gingival sulcus was 10mm. Dehiscencia was seen in the patient

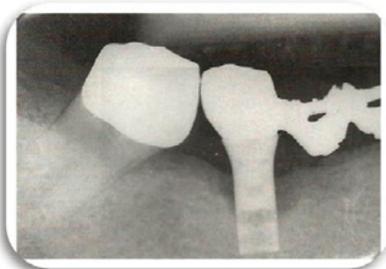
Figure 12: Preoperative intraoral radiography, where bone resorption was seen.

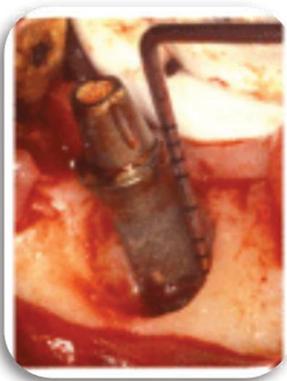
Figure 13: Careful removal of granulation tissue, circular loss of bone tissue.

from the buccal side of the implant (Figure 13). The bone defect was closed with a bone graft (Figures 14-16).

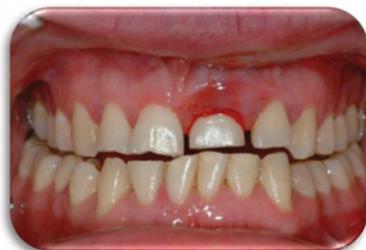
Figure 21: The bleeding from the affected dental implant 21 was seen. Image taken before operative treatment.

The third clinical cases was a 47 year old male patient with a dental implant [21], placed in the frontal region of the maxilla. More precisely, implant compensates for the naturally lost central left incision. After three months of dental implant placement, the patient began to complain of pain coming from the area where the dental implant was placed. The marginal gingiva in that region was oedematous and hyperemic, and blood was drained during the process of probing. The peri-implant mucositis was detected. On the figures 21-25 the situation before the surgery treatment was seen.

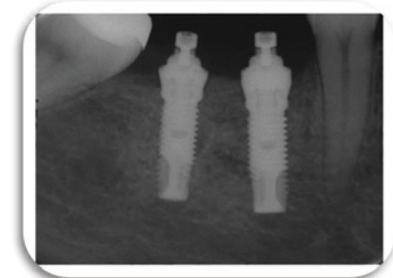
Figure 30: Dental implants placed at positions 45 and 46.

disease. In the clinical examination, it was found that the gingiva around the dental implants was swollen and hyperemic. The impressions and minimal bleeding were observed on the gingival palpation. The bleeding from the gingiva occur during the process of probing, and pocket depth of 3.5 mm was detected. After the performed x-ray examination, a very small marginal bone resorption was detected and no surgical intervention was required (Figures 30-32).

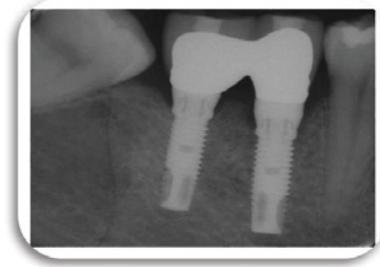
Figure 31: Control X-ray taken after a period of 9 months from the implants placement. Minimal marginal bone resorption was observed.

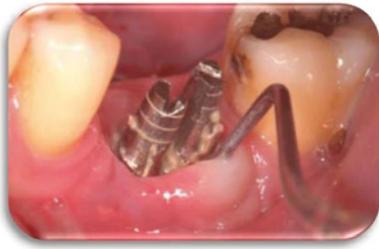
Figure 36: Probing around the dental implants, where the depth of the pocket that is formed was 10 mm.

Two dental titanium implants were placed in a 37 years old, male patient. These two dental titanium implants were placed one year ago and their position is 36, they compensate the lower left first molar. The patient come to dental office on control because he felt pain in the area of dental implants. The pain, except during mastication, was also manifested during the brushing of the teeth, and was accompanied by bleeding from the gums. Gingiva was hyperemic and oedematous (Figure 36), and X-ray control images were also made, which can be seen below (Figure 37-40). During the process of probing, the dental probe drowned in bone pocket around the dental implants at a depth of 10 mm.
