# INTERVENTIONAL MANAGEMENT OF SUPERNUMERARY TEETH: AN ORTHODONTIC AND SURGICAL PERSPECTIVE

**Aim:** To present a case of mesiodens in an 8-year-old male patient and the course of its interdisciplinary oral surgical and orthodontic treatment, with whom we prevent functional and esthetic orthodontic anomalies.

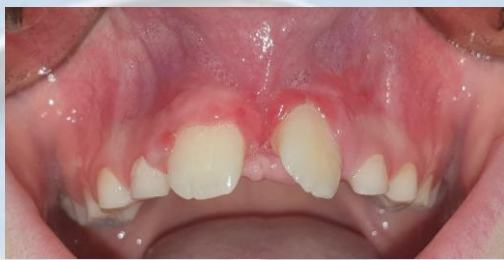
Picture 1. Status intraoralis preoperativa

**Case report:** This case study presented an 8-year-old male patient diagnosed with dens supernumeraria 21. At the first examination, the presence of an atypical, microdontic, fully formed and cranially oriented mesiodens, placed in the middle of the alveolar ridge, was confirmed clinically and orthopantomographically. Oral surgical intervention was carried out. After a horizontal incision from the vestibular side, relaxing distal osteotomy was performed to visualize the mesiodens and expose it. Surgical extraction of the mesiodens was done, an in-toto enucleation of the cystic sac was accomplish and the cavity was filled with Gela tamp. A suture was placed. One month after the surgical intervention surgical field with the primary lateral right incisor also extracted, was in perfect condition. It was recommended extended orthodontic observation.

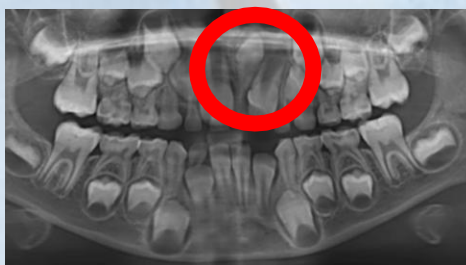
Picture 2. Rtg Panoramix

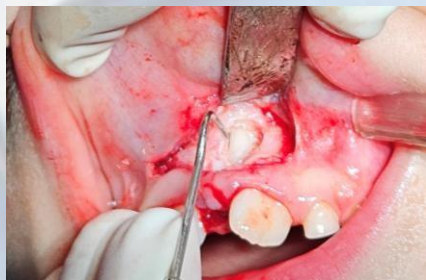
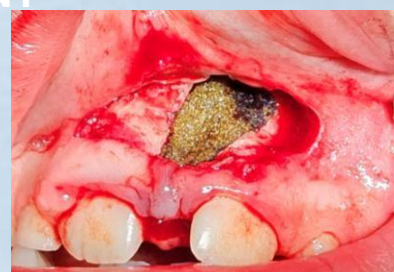
Picture 4, 5. Surgical extraction of the supernumeraria 21 with enucleation of the cystic sacus and application of the gelastip in the cavity
